# Rattling noises due to oil sludge in the vacuum pump

Vehicle	Product	PIERBURG No.
VW Transporter LT, T4	Vacuum pump	7.22300.62.0/.69.0

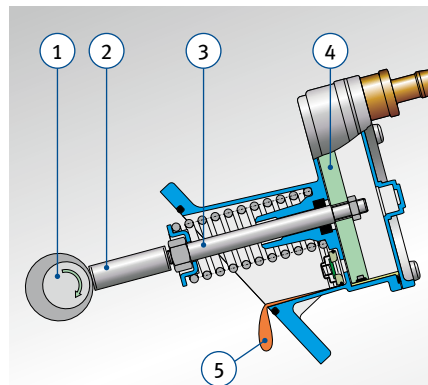
Fig. 1: Recommended installation position

In the recommended installation position, the engine oil can flow back to the engine (Fig. 1).

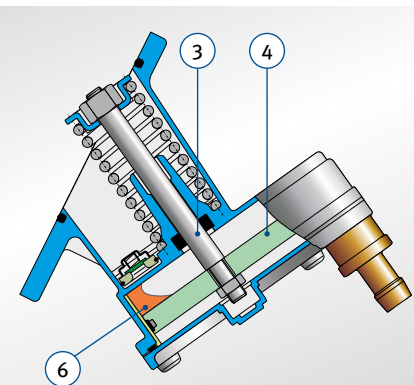
Fig. 2: Installation position VW LT and T4

The installation position in the VW Transporter is as displayed in Fig. 2. If oil is not changed regularly, the engine oil ages. Oil sludge with viscous consistency builds up between piston crown and housing.

This prevents the piston from reaching its end position. There is leeway between tappet and connecting tappet. This results in tapping noises, which sound like bearing damage on the crankshaft.

In case of oil sludge deposits the vacuum pump must be replaced. It cannot be cleaned, as the vacuum pump cannot be opened with ordinary tools and there are no spare parts.

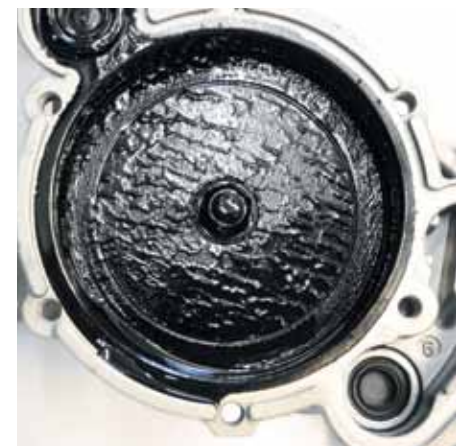
- Intervals for changing oil not adhered to
- Insufficient quality of engine oil
- Soot formation due to unclean combustion
- Faulty exhaust gas recirculation

Fig. 3: Oil sludge in the vacuum pump of the VW Transporter results in rattling noises
