Throttle housing Streamlined range

si 0069 GB

Vehicle: Mercedes-Benz

Product: Throttle housing

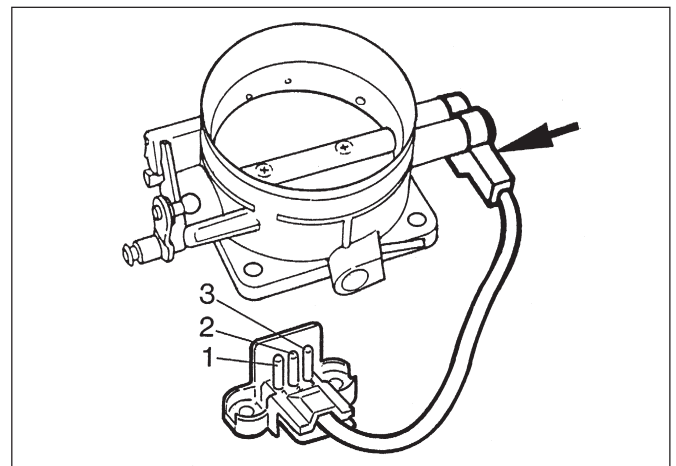
Fig: Throttle housing of a similar type

The listed throttle housings are fitted with a switch for idling and full-load detection (see → arrow in Fig.)

- Faulty throttle switch
For testing the switch → see below
- Worn throttle shaft (vehicles with high mileage)

In both cases, the complete throttle housing must be renewed.

- Connect ohmmeter to terminals 1 and 2 (see → Fig.)
- Move throttle into idle position
Required value: < 1 Ω
- Lift throttle by 0.2 mm from the stop screw
Required value: ∞ Ω
- Connect ohmmeter to terminals 2 and 3 (see → Fig.)
- Move throttle to full load
Required value: < 1 Ω
- Turn throttle slightly towards idle position
Required value: ∞ Ω
