Regulating Throttle Failure

in the VW Touran, Golf V, Audi A3 with 2.0 TDI engine

Vehicle	Product: Regulating throttle		
Audi A3 2.0 TDI	PIERBURG No. 7.14393.26.0	Replacement for 7.14393.11.0/.16.0/.20.0	O.E. No.* 038128063G
VW Touran 2,0 TDI			
VW Golf V 2.0 TDI

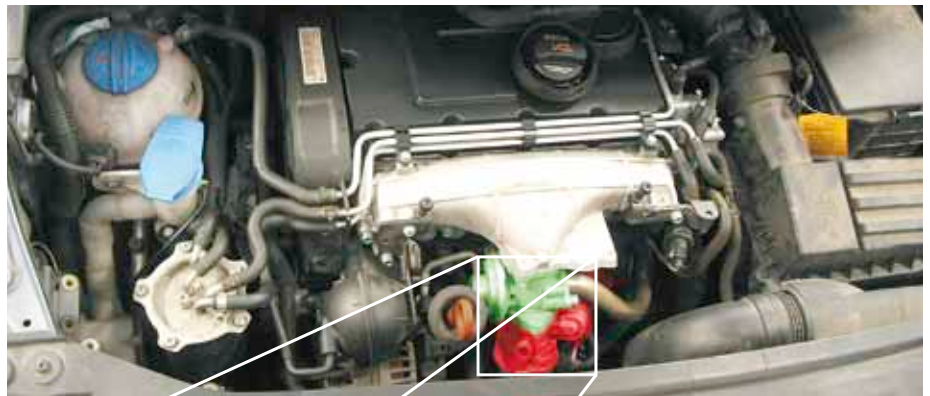
View into the engine compartment of the Touran
 Emphasised in green: EGR valve
 Emphasised in red: regulating throttle

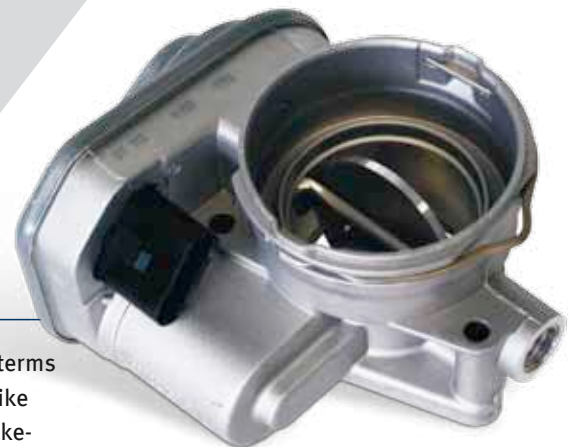
Product view of the regulating throttle

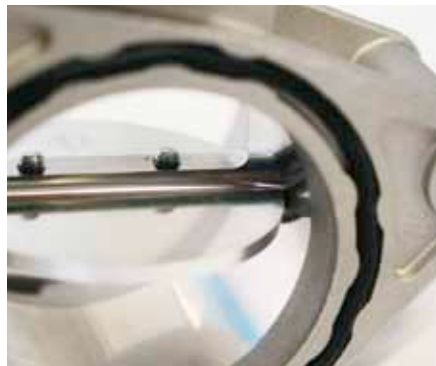
New regulating throttle

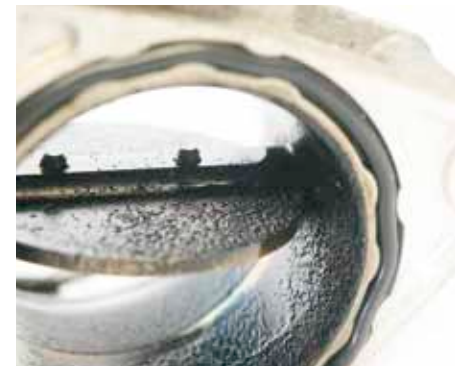
Regulating throttle suffering from oil contamination

We do not recommend cleaning of the regulating throttle:

- In the case of a defective regulating throttle suffering from the damage described overleaf, cleaning will not result in an improvement.
- A functional regulating throttle could be damaged by cleaning it.
