# SERVICE INFO

## Important information on avoiding clutch pedal vibrations

**Engine:** 1.9 TDI

**Engine codes:** BKC, BLS, BXE

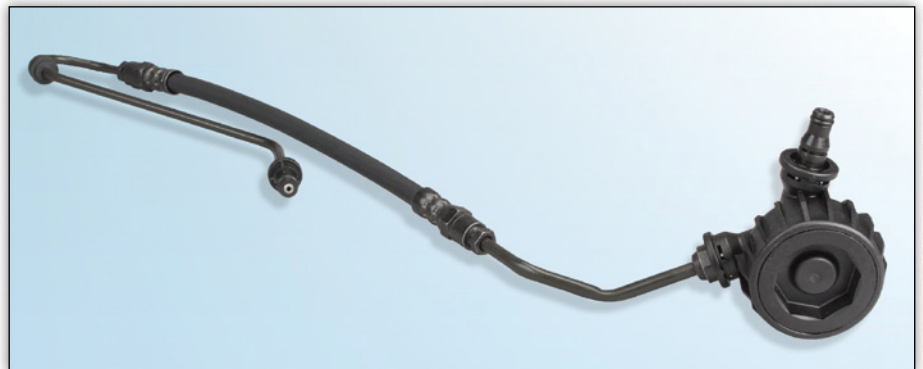
**Image 1:** Hydraulic line with frequency modulator (anti-vibration unit)

From model year 2003, the vehicles listed above may experience vibrations on the clutch pedal when actuated.

In the event of a complaint, the cause can be attributed to the absence of or a faulty frequency modulator (anti-vibration unit), or to the fact that the electronic control unit software is not up to date.

The vibrations are generated as a result of axial torque deviations in the crankshaft, which are transferred to the pedal via the clutch hydraulics.

The frequency modulator suppresses pulsations in the system's hydraulic fluid, thereby preventing vibrations on the clutch pedal.

Schaeffler Automotive Aftermarket therefore recommends the following test procedure:

- Is the electronic control unit software up to date?
- Is a frequency modulator fitted?

If necessary, the hydraulic line with frequency modulator should be replaced and subsequently refitted. The corresponding replacement parts are available from the vehicle manufacturer.
