# Misalignment of diaphragm spring fingers

Manufacturers: PSA/Peugeot, Citroën

LuK RepSet: 623 3325 00  
623 3325 09  
623 3325 33  
601 0021 00

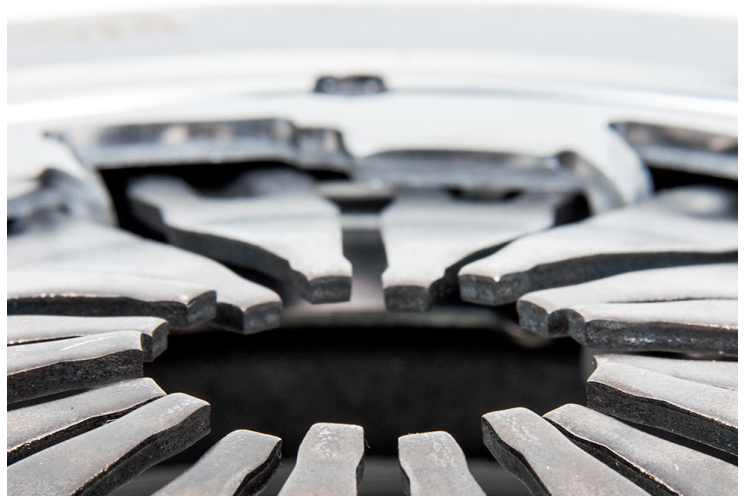
Fig. 1: Misalignment of diaphragm spring fingers on a dismantled clutch

The diaphragm spring fingers of the pressure plate in the LuK RepSet are misaligned in its uninstalled condition (Fig. 1). This design characteristic is safe and does not represent a component defect.

During the installation of the clutch, the diaphragm spring aligns itself to its working position. In so doing, the diaphragm spring fingers align themselves properly and provide the correct operation of the clutch.
