**Clutch adjustment gauge
for Vauxhall/Opel vehicles
with 4- and 6-cylinder
CIH engines**

400 0009 10

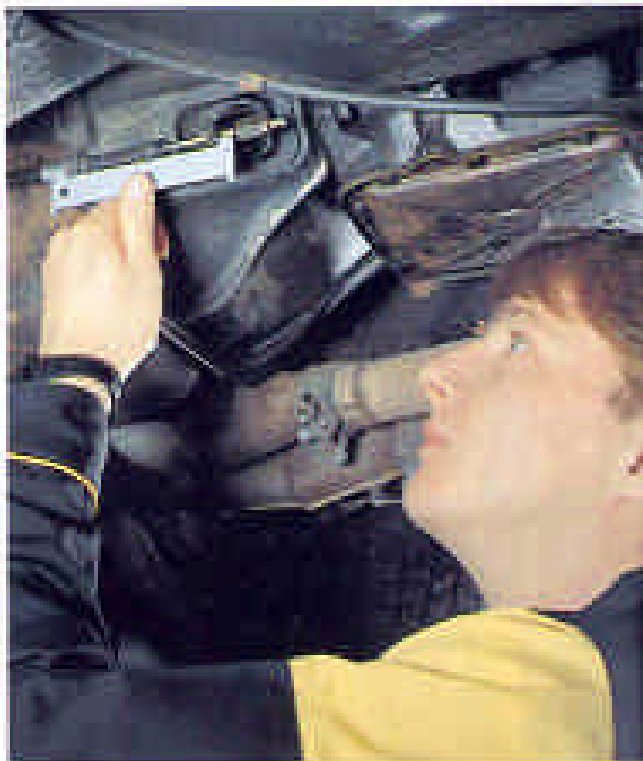
The basic setting is carried out on the release bearing operation fork. The prescribed dimension for the adjustment corresponds to the distance from the clutch operating fork to the outer edge of the clutch housing in the direction of the engine. This measurement can be read off by placing the adjustment gauge on the clutch housing and on the clutch operating fork.

The measurement to be checked is:

8-inch clutch ($\varnothing 200$ mm) = 110 mm

8½-inch clutch ($\varnothing 215$ mm) = 110 mm

9-inch clutch ($\varnothing 230$ mm) = 122 mm

The adjustment screw of the clutch operating fork release bearing system is to be turned, after releasing the locknut, until the adjustment setting is reached. The adjustment screw is then secured with the locknut.
